AR 15-6 Investigation

Operation Cnoclaw  
Non-Combatant Death

# Event

# Photos of House Post-Impact

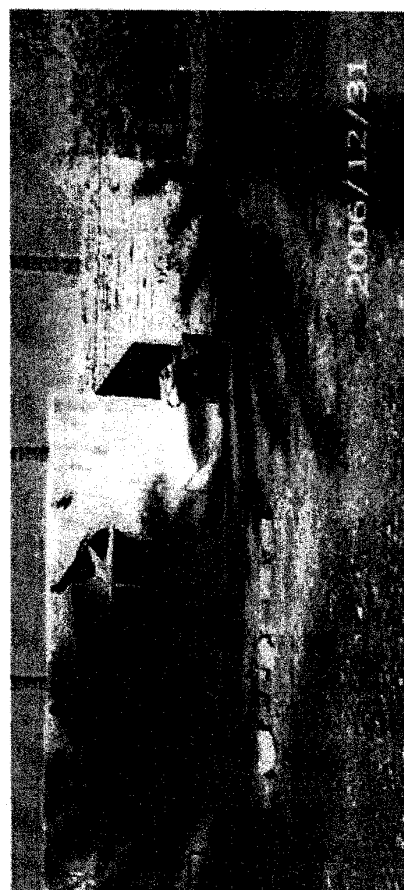
Exterior - broken glass and shattered door

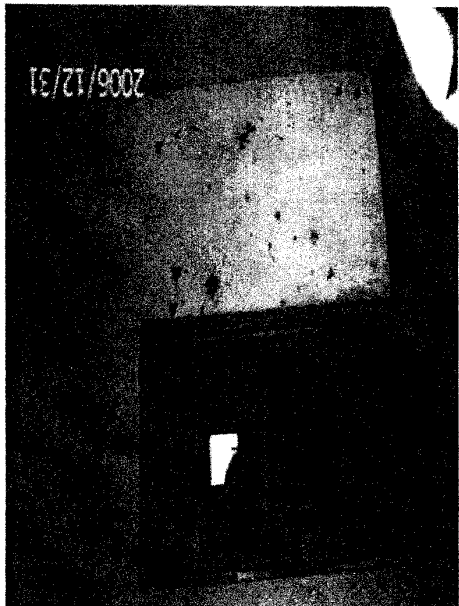
Interior - looking into kitchen area

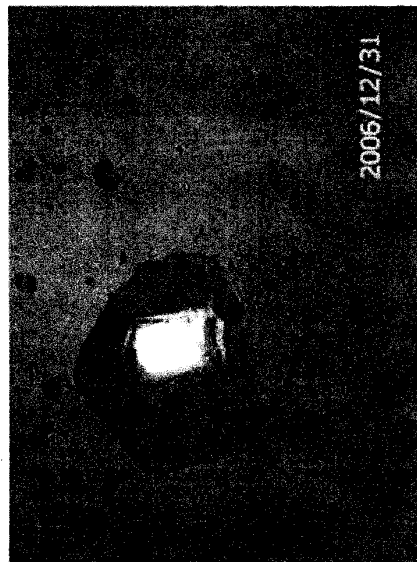
Entrance of round through Roof
