# Projectile Comparison Presentation

ENCLOSURE C to 15-6 Informal Investigation Concerning the Shooting and Death of a Local National (LN)

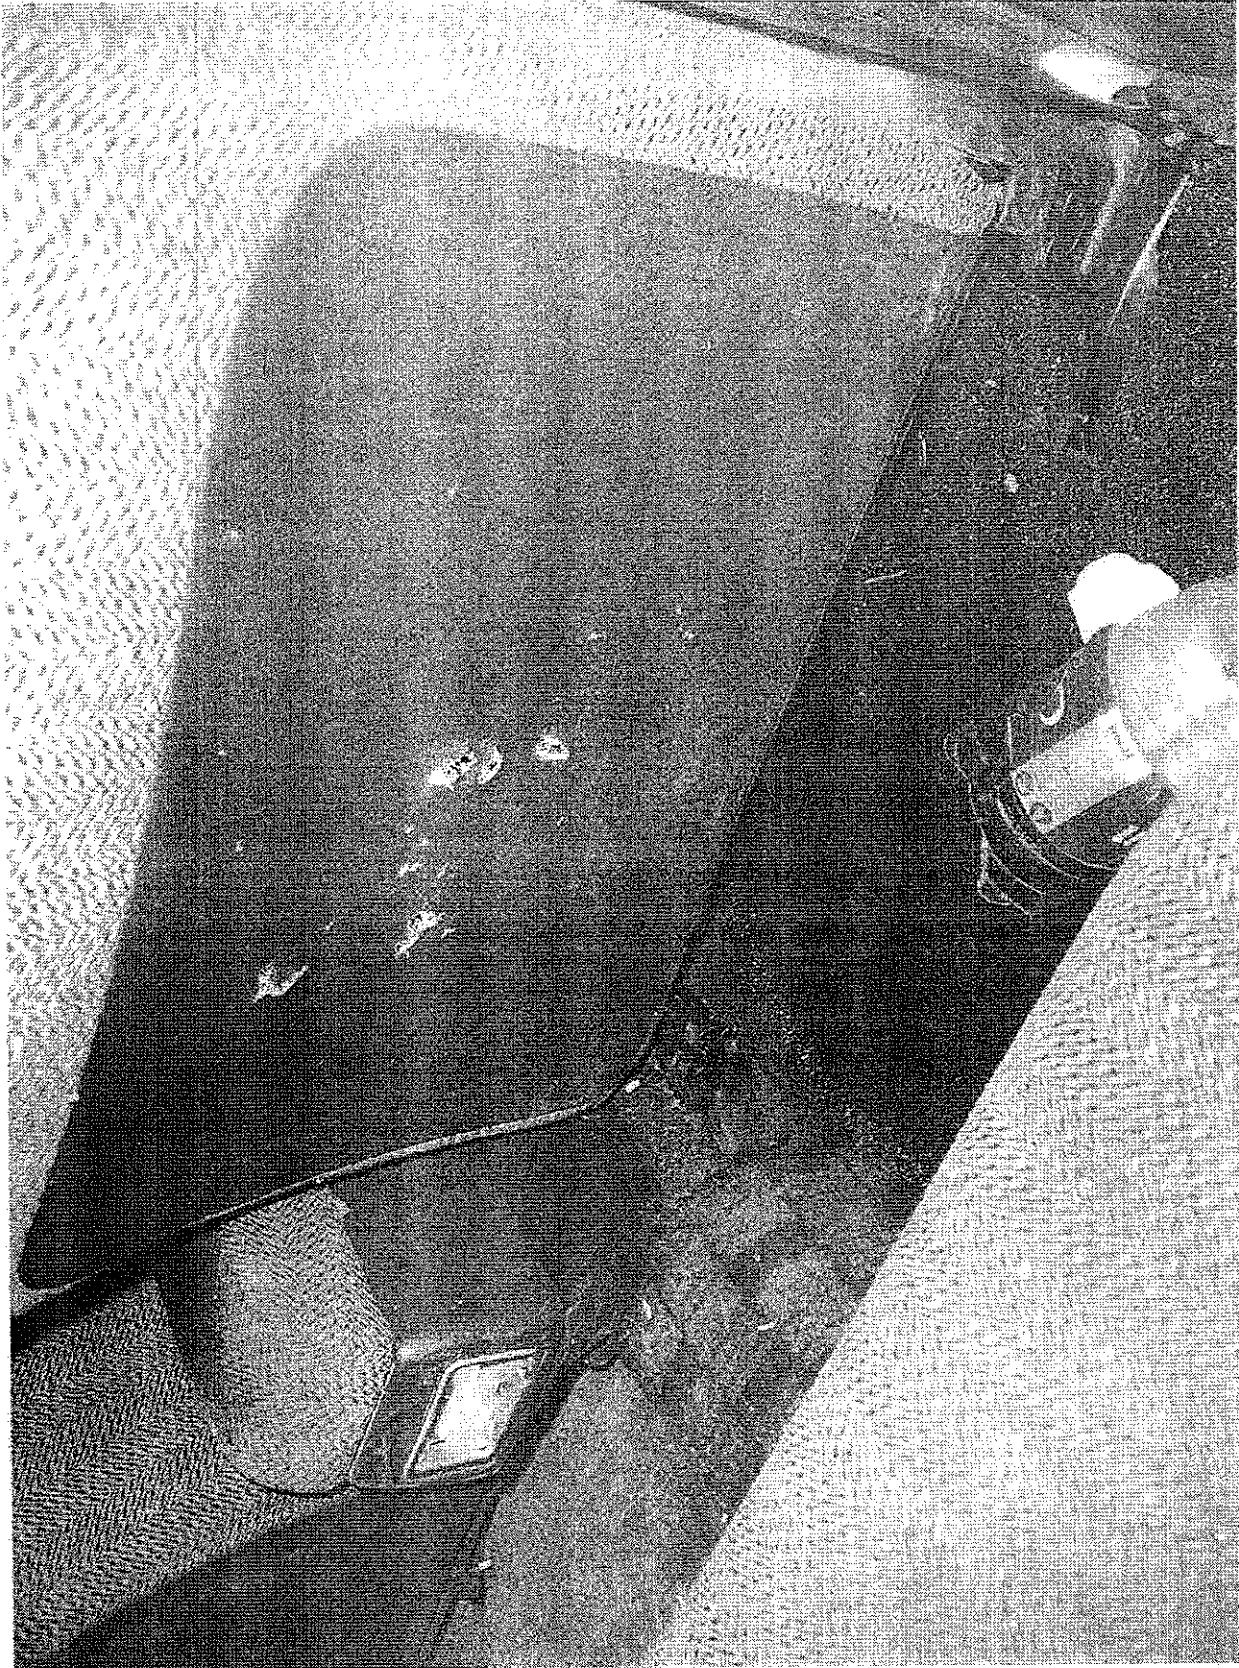
The back seat on the night of the incident.

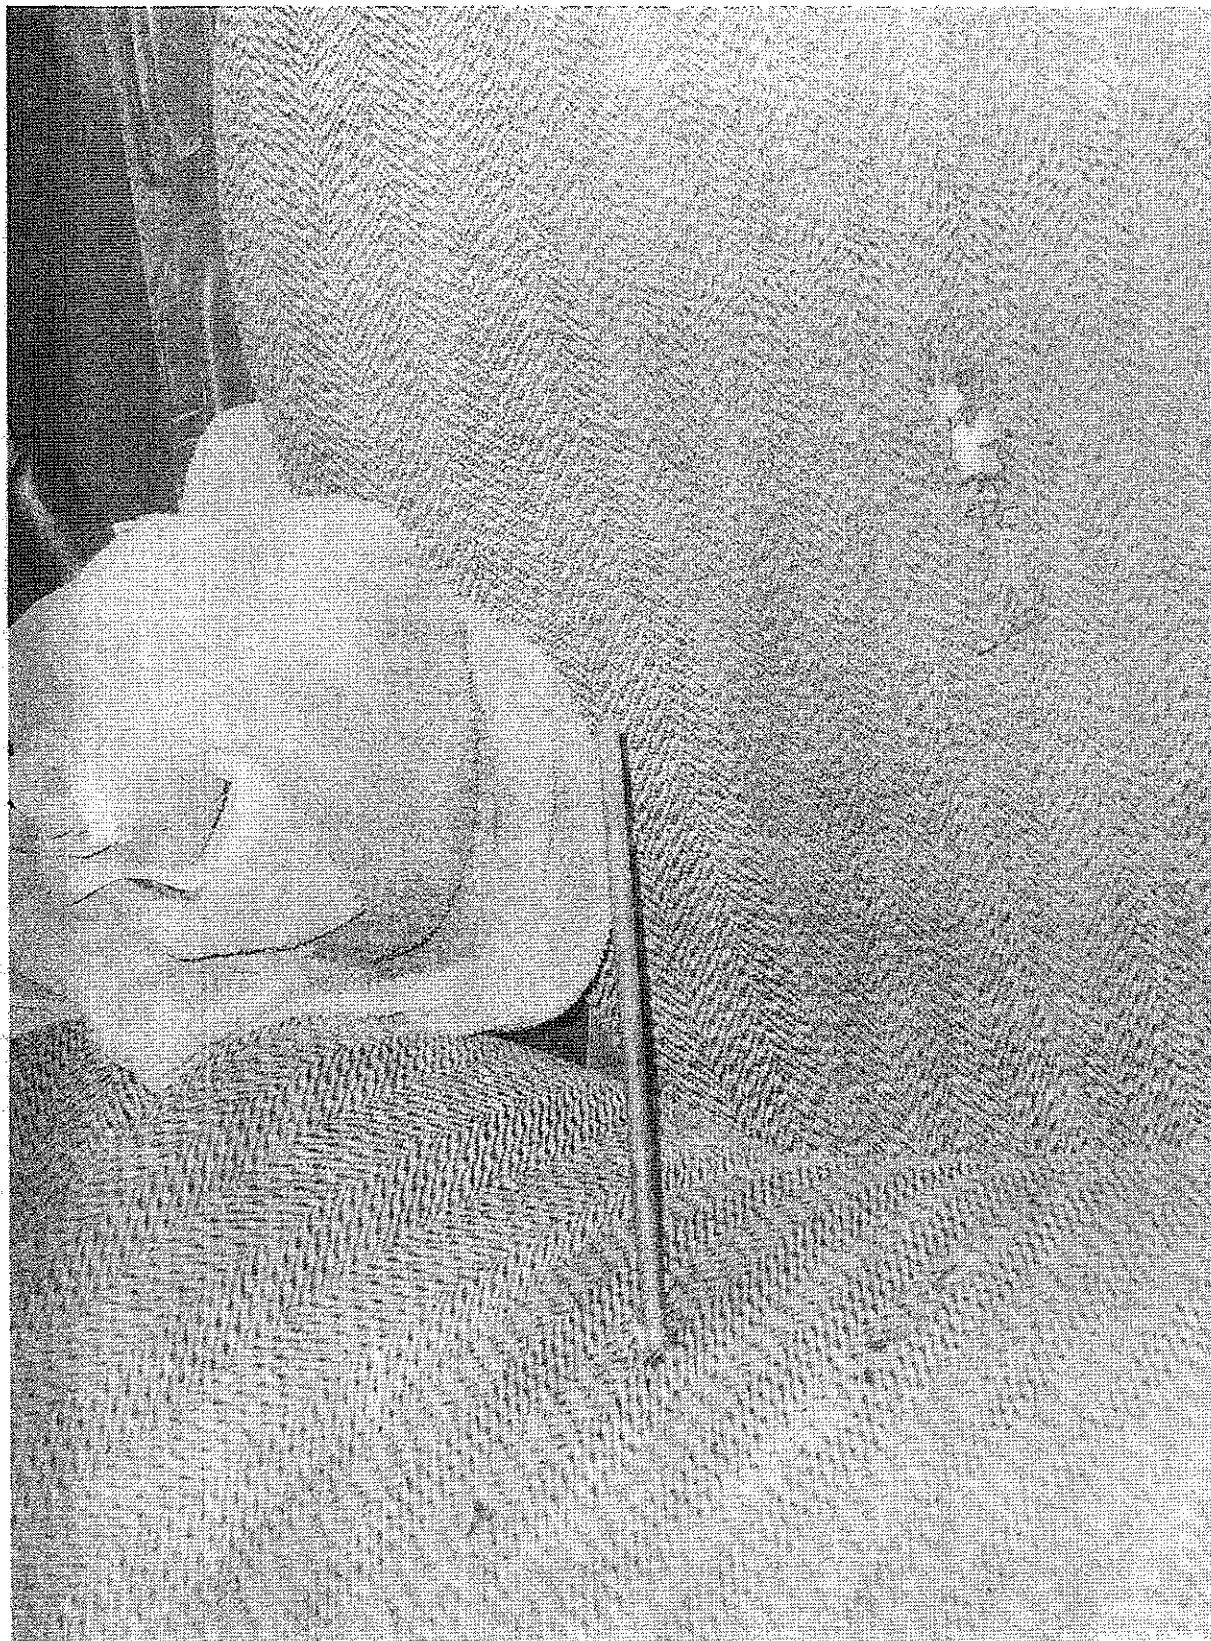
The seat where the woman was sitting when she was struck by the round. Notice the fragmentation and the trajectory of the round again represented by the antenna.

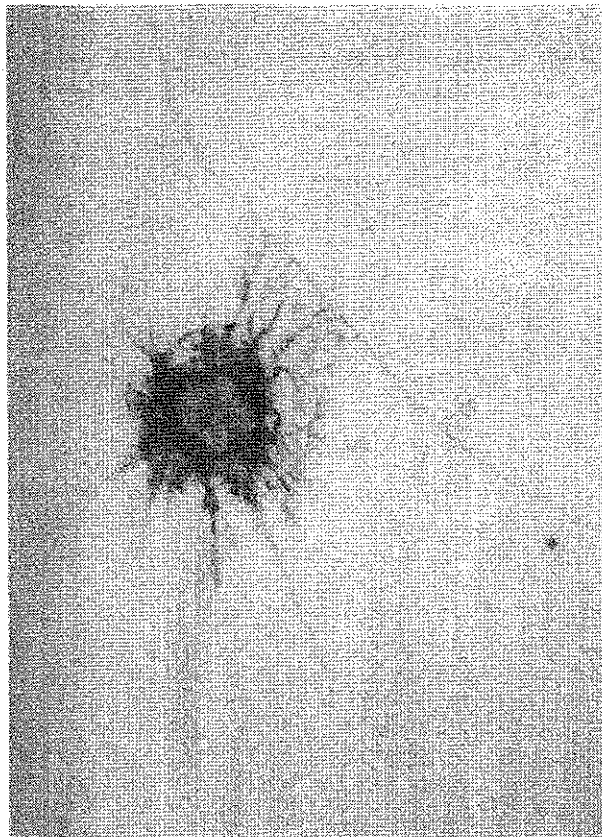
The hole in the glass, from the inside of the car looking out. On the inside, the glass has been dug out, to form an upside down crater suggesting that the impact came from the *inside* not from the outside like from a rock or something else.

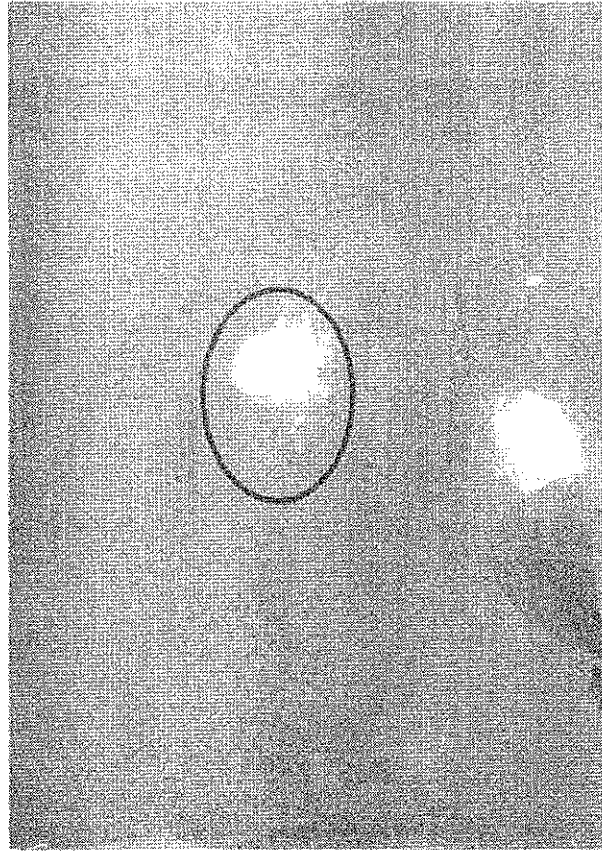
The hole in the windshield from the outside of the vehicle.

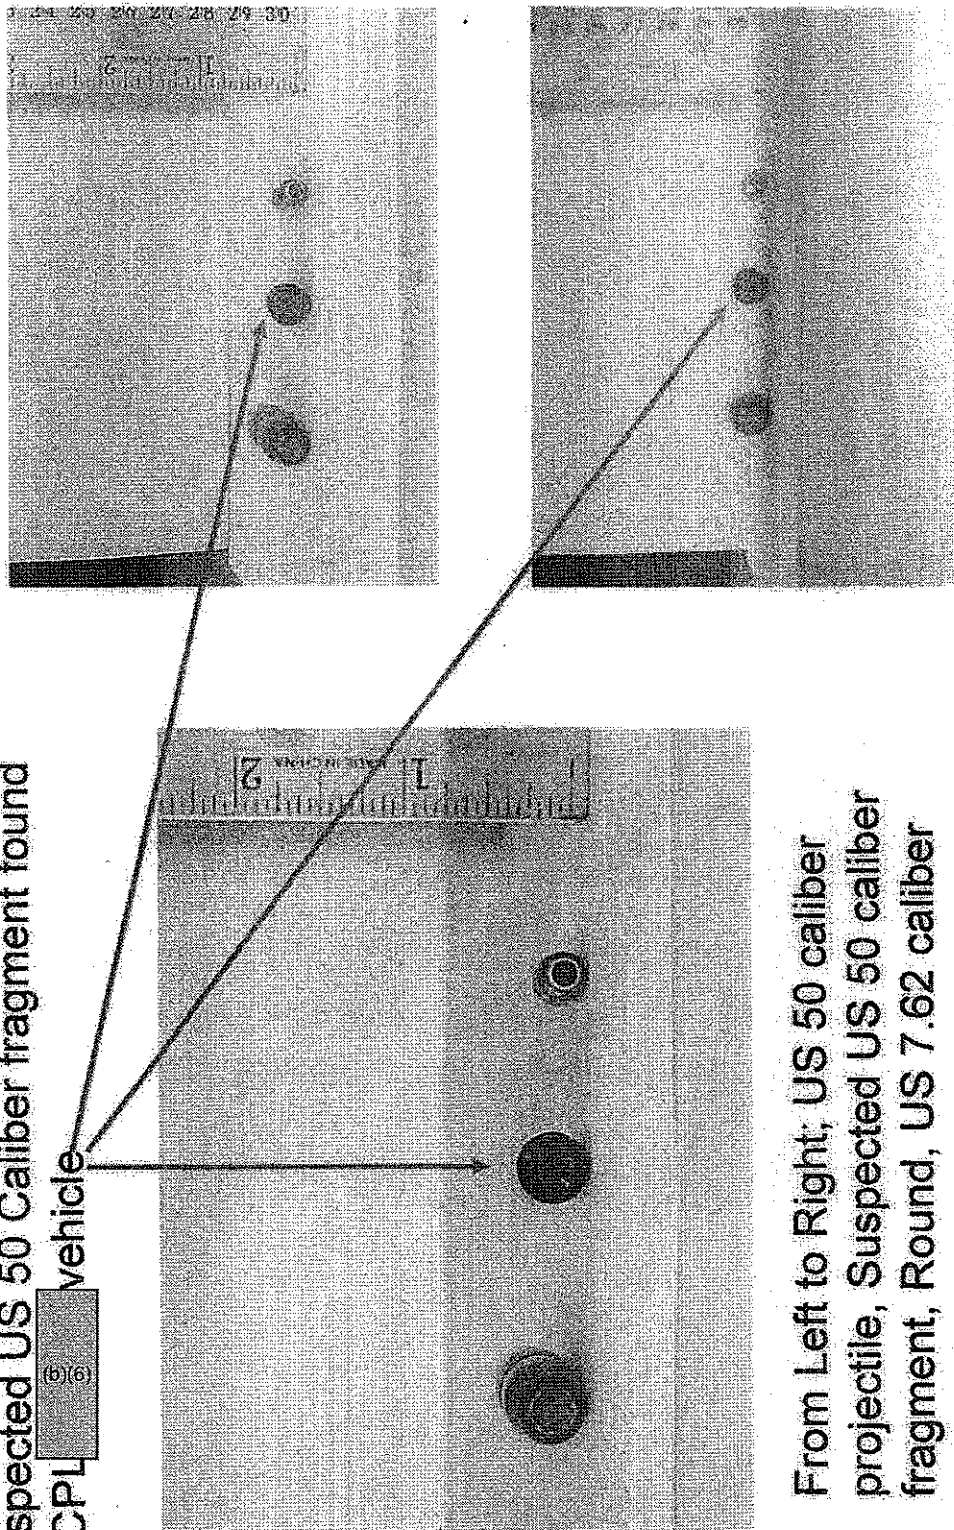
# Projectile Comparison (1 of 3)

Suspected US 50 Caliber fragment found  
in CPL (b)(6) vehicle

From Left to Right; US 50 caliber  
projectile, Suspected US 50 caliber  
fragment, Round, US 7.62 caliber  
projectile
