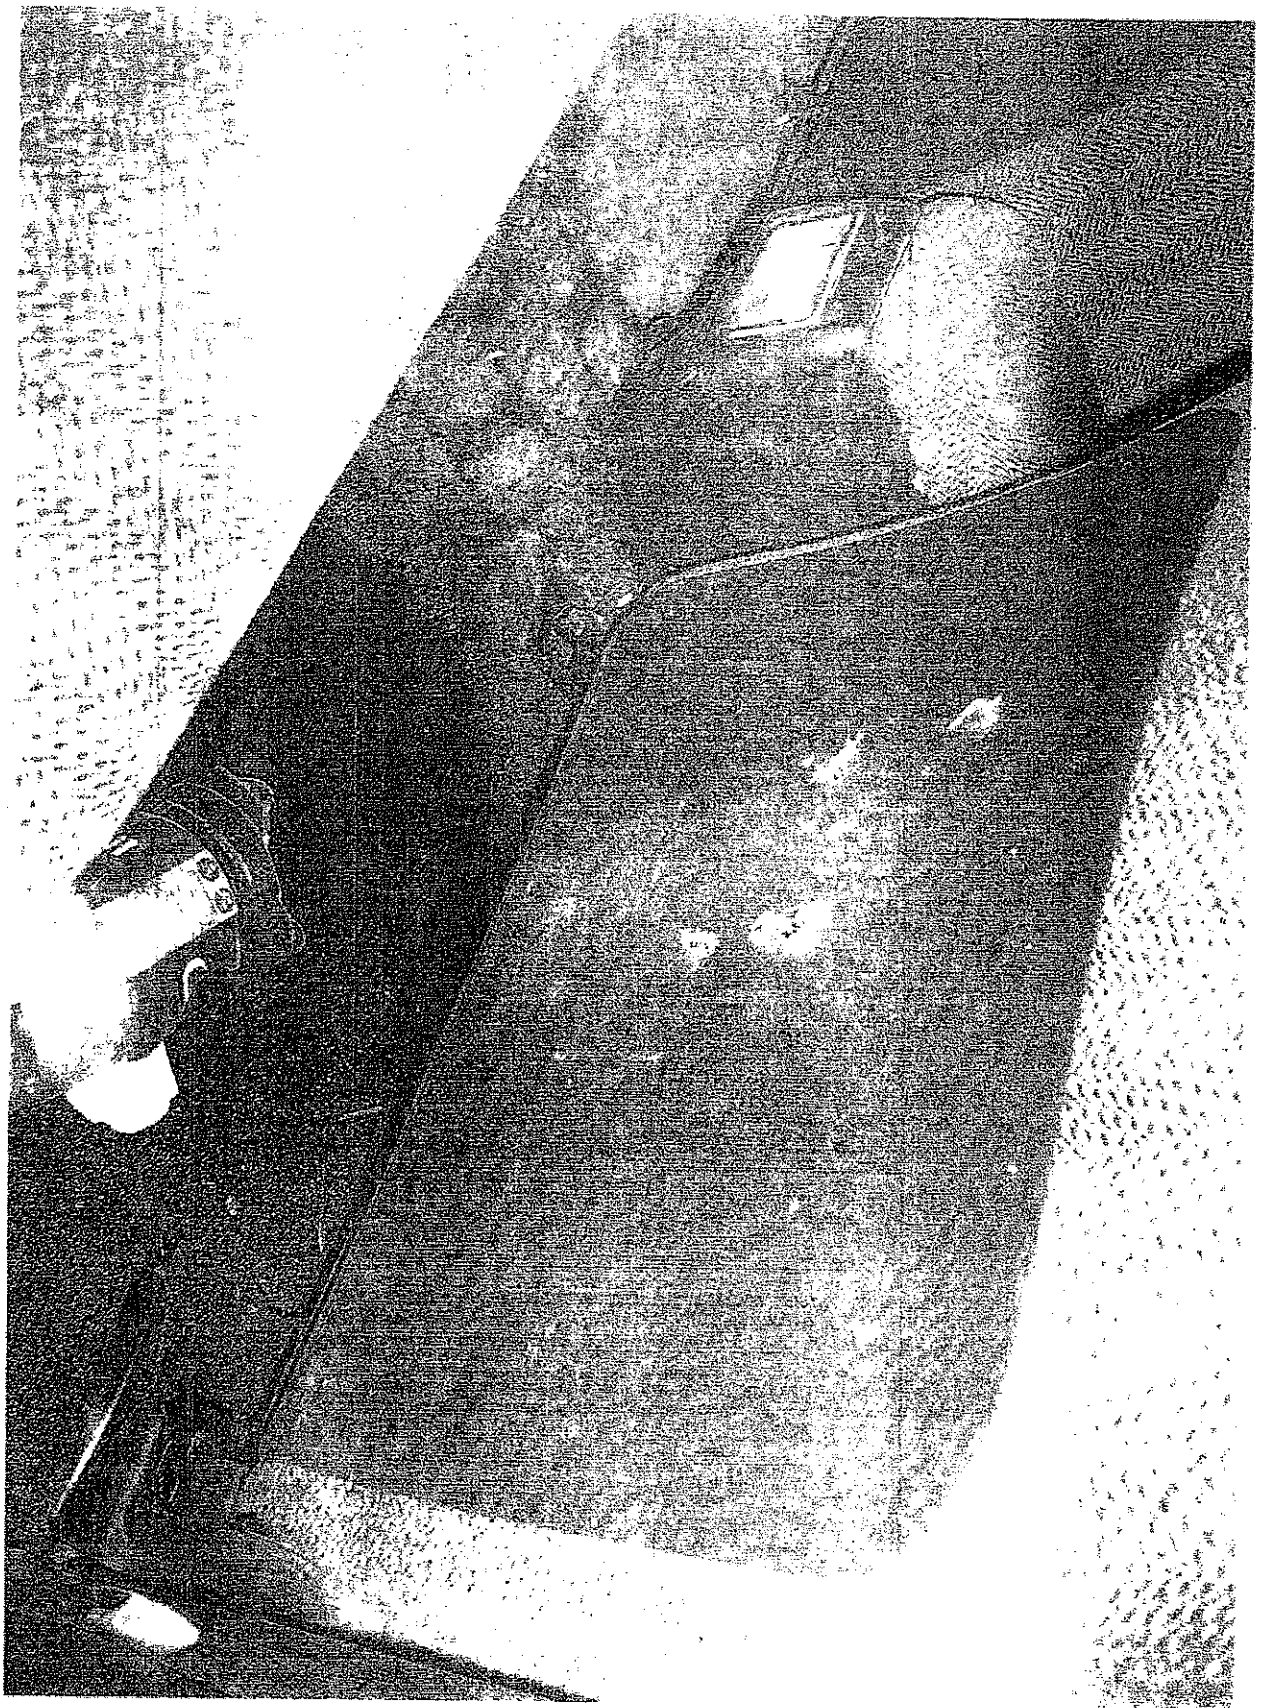
The back seat on the night of the incident.

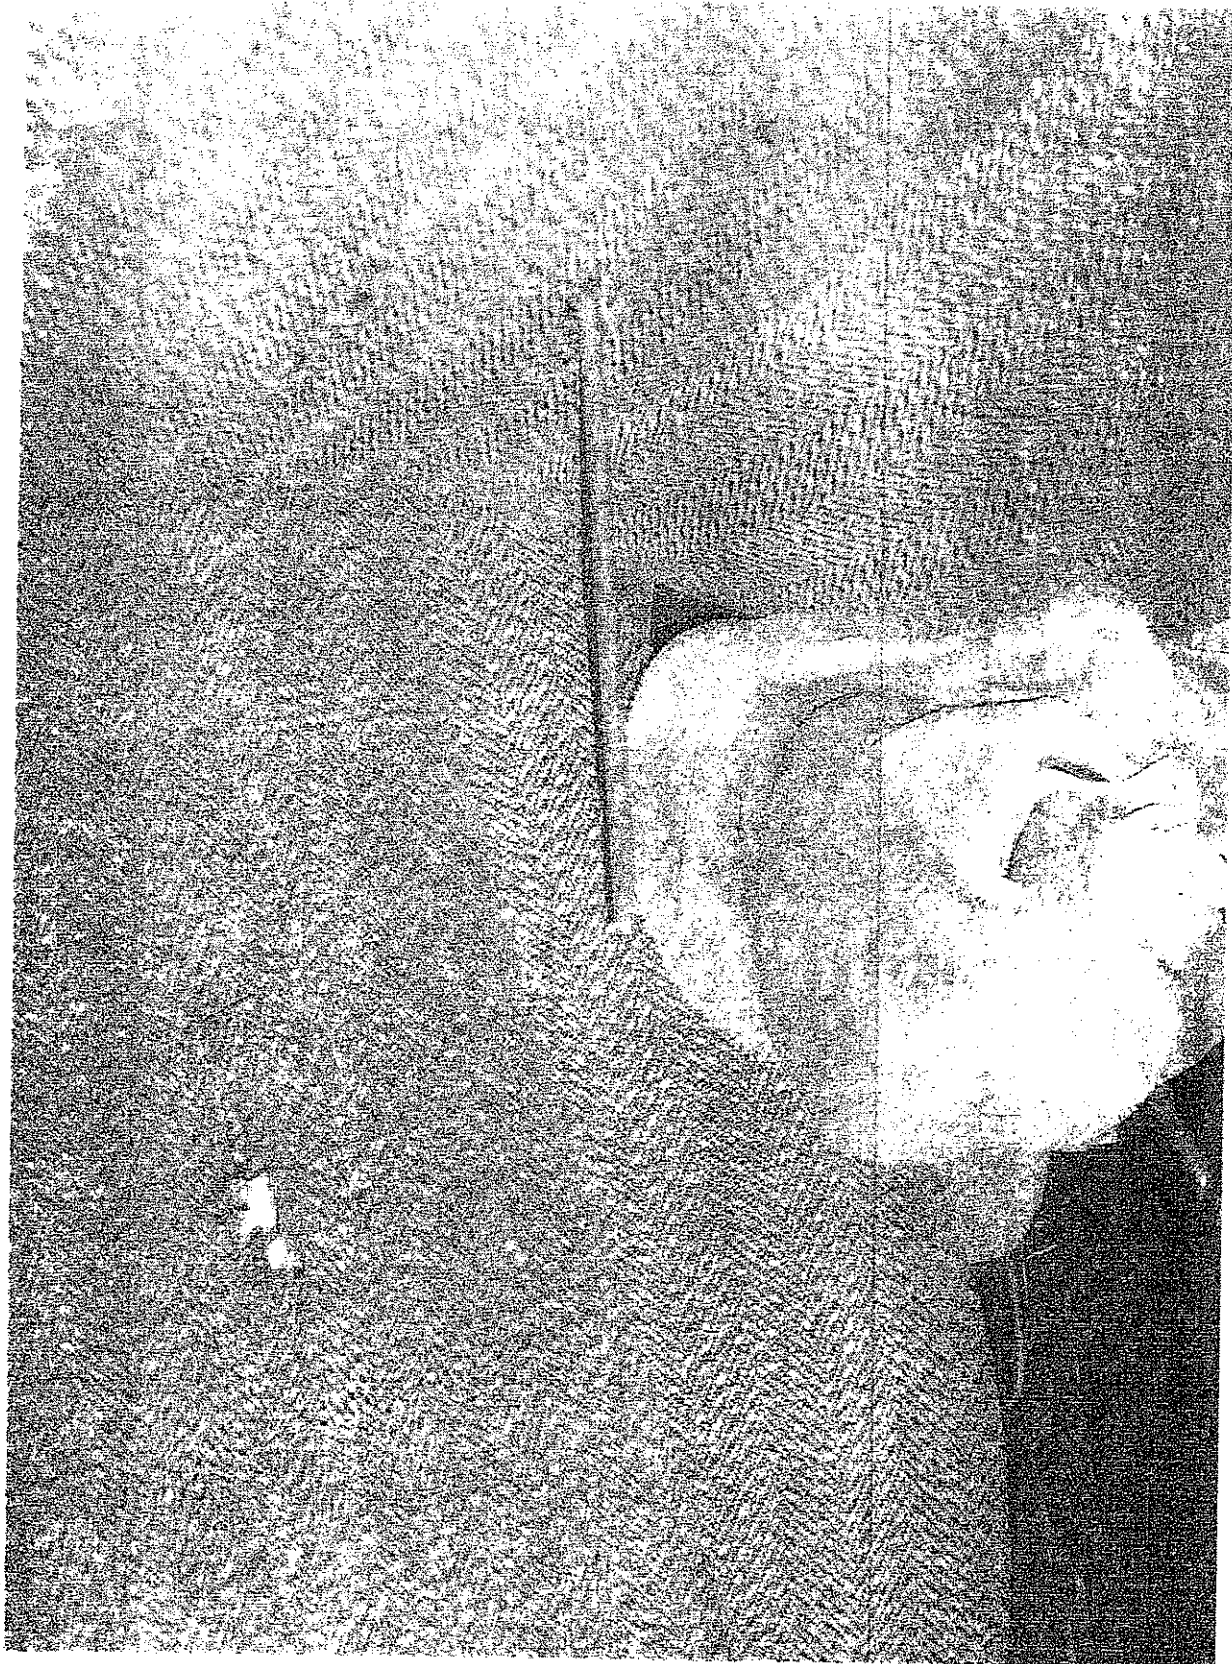
The seat where the woman was sitting when she was struck by the round. Notice the fragmentation and the trajectory of the round again represented by the antenna.

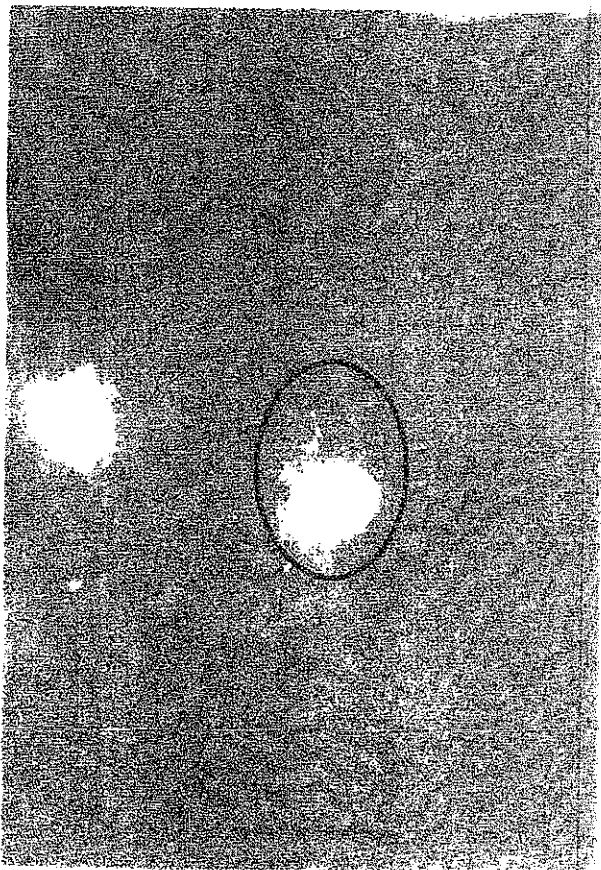
The hole in the windshield from the outside of the vehicle.

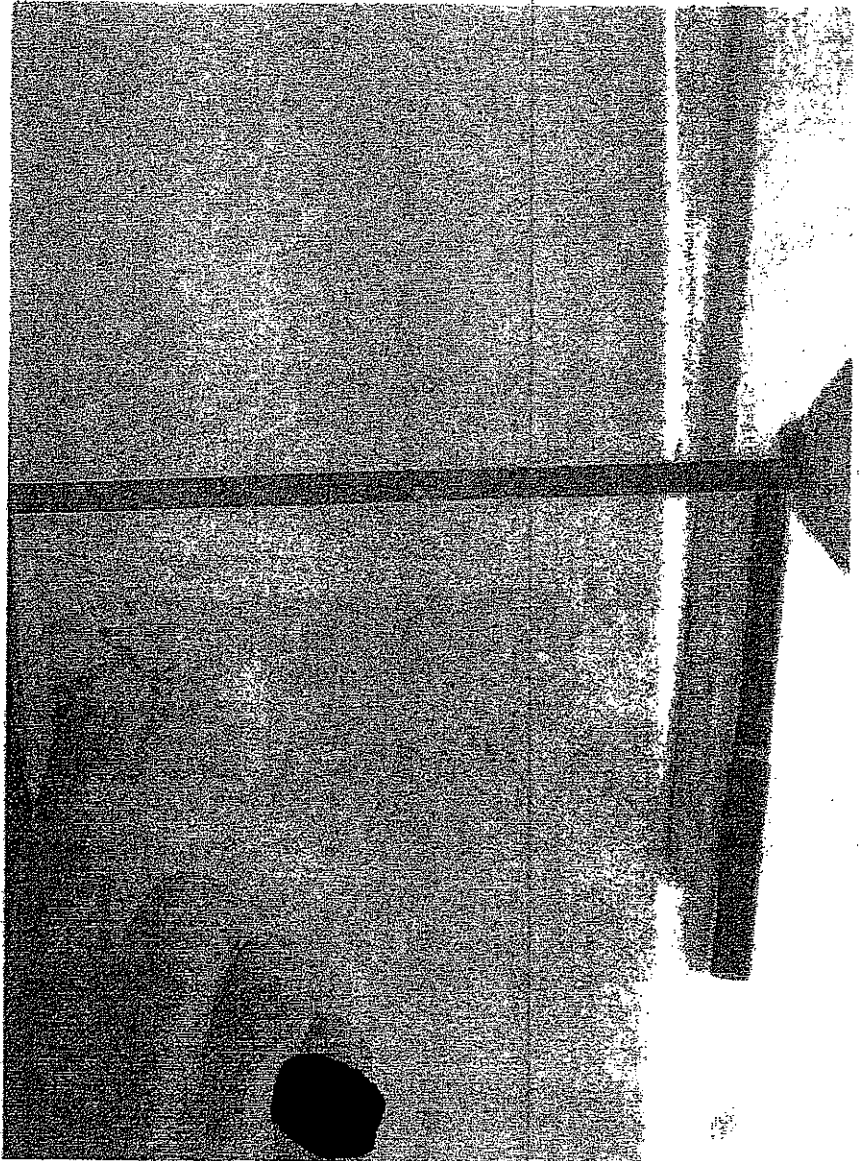
The bullet hole was patched up since the initial picture taken on the night of the incident. The red dot indicates a height of 3 feet. The center of the hole is 2 feet 10 inches above the road surface and is located underneath the index finger in the photo.

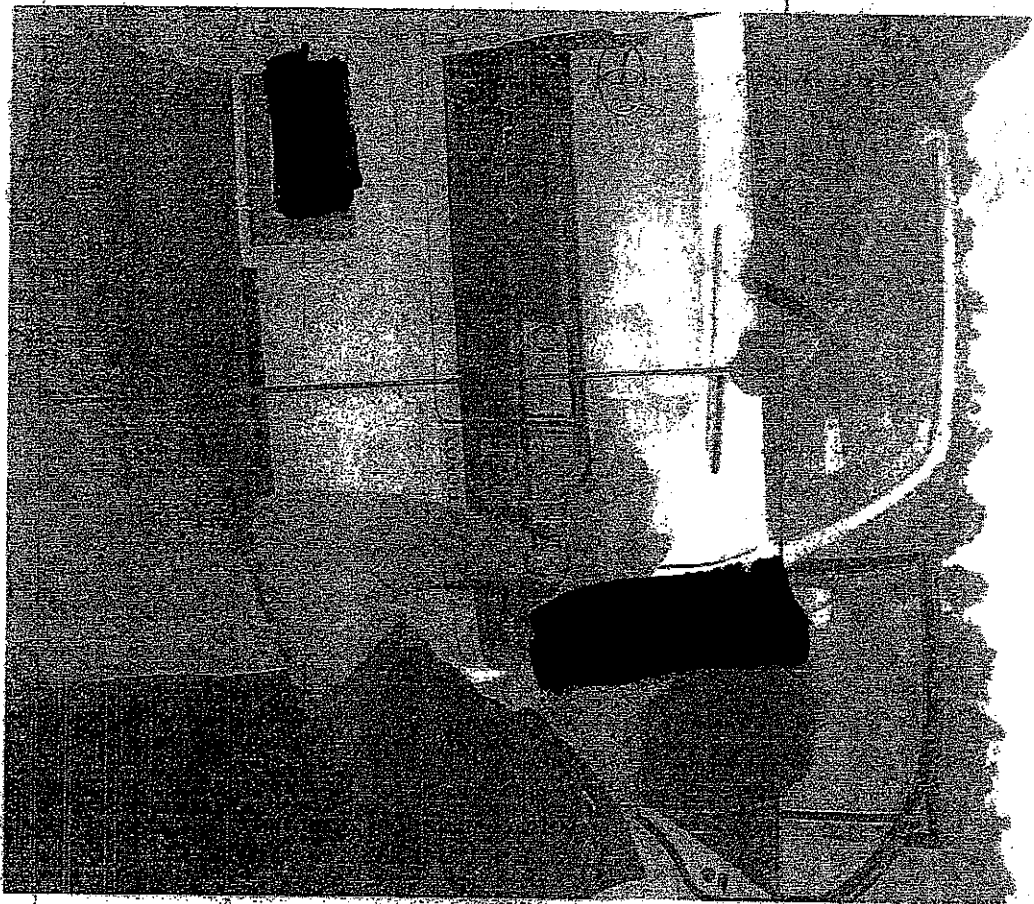
A wider shot of the previous photograph. Again, notice the red dot on the antenna, which is pointing at the three foot mark above the ground. The interpreter's index finger is centered over the patched bullet hole.
